Report 1443

## THE EFFECTS OF ATOMIC WEAPONS ON

ENGINEER HEAVY EQUIPMENT (U)

25 April 1956

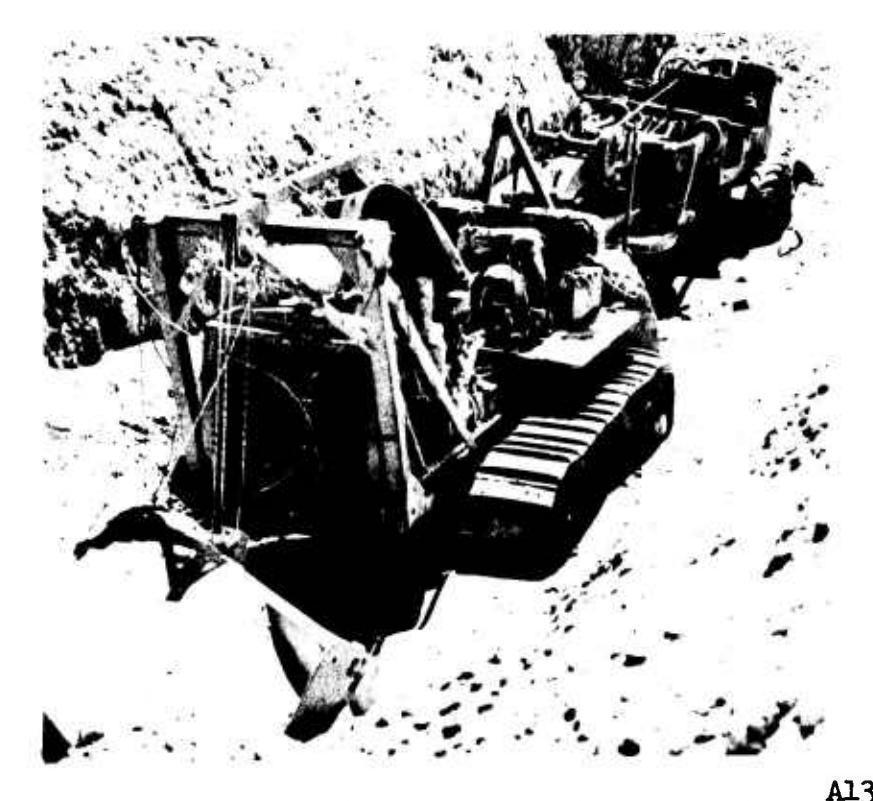
A13314 Fig. 8. Caterpillar D-8 angledozer, 1600 ft; after test.

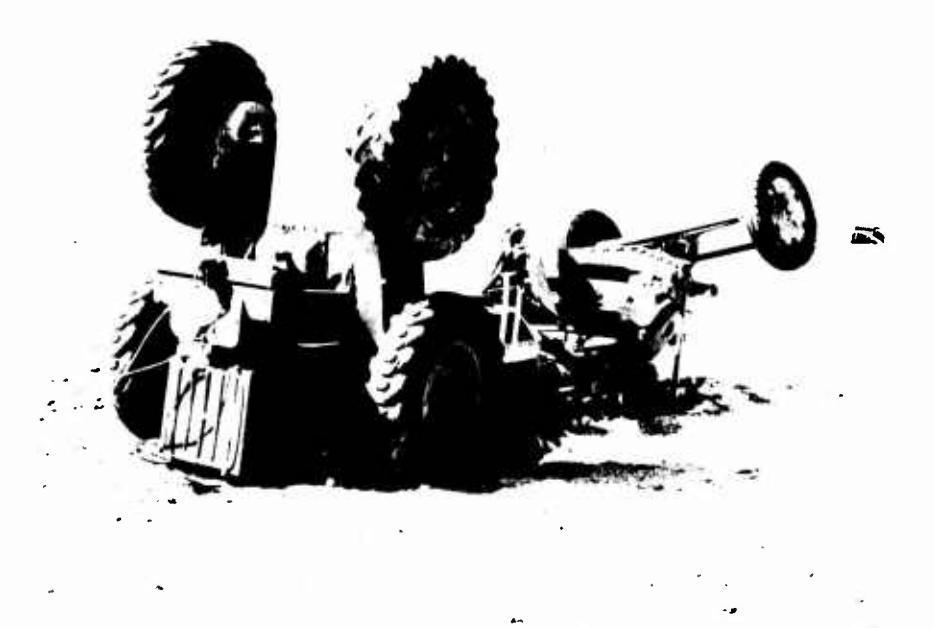
(see also Fig. 8). In Fig. 12, GZ is to the left front; and in Fig. 13, GZ is behind the camera. Fig. 13 shows the condition of the grader after the test was conducted at 2100-ft range. When this figure is compared with Fig. 7, it can be seen that the sturdier, more compact tractor suffered less damage than the grader did under the same conditions.

Fig. 13. Grader, 2100 ft; after test.

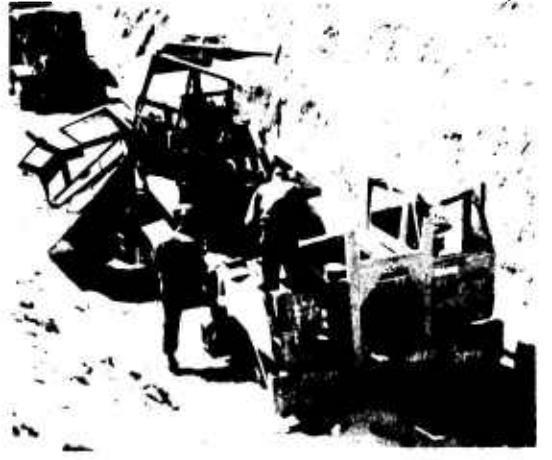
c. <u>Cranes</u>. At the 2100-ft range, the exposed crane was destroyed, and the protected crane received a surprisingly high degree of damage. At the 2700-ft range, the exposed crane still received extensive but moderate damage, while the protected crane was moderately damaged but to a lesser extent because of the shielding effect of the slot. (See Figs. 14 through 19 and note the sheet metal panels of the crane housing and cabs, particularly inside the slots.) Booms and other attachments would have been damaged in about the same degree as the cranes themselves.

Al3204 Al3255 Fig. 14. Crane, 2100 ft; be- Fig. 15. Crane, 2100 ft; after fore test. test.

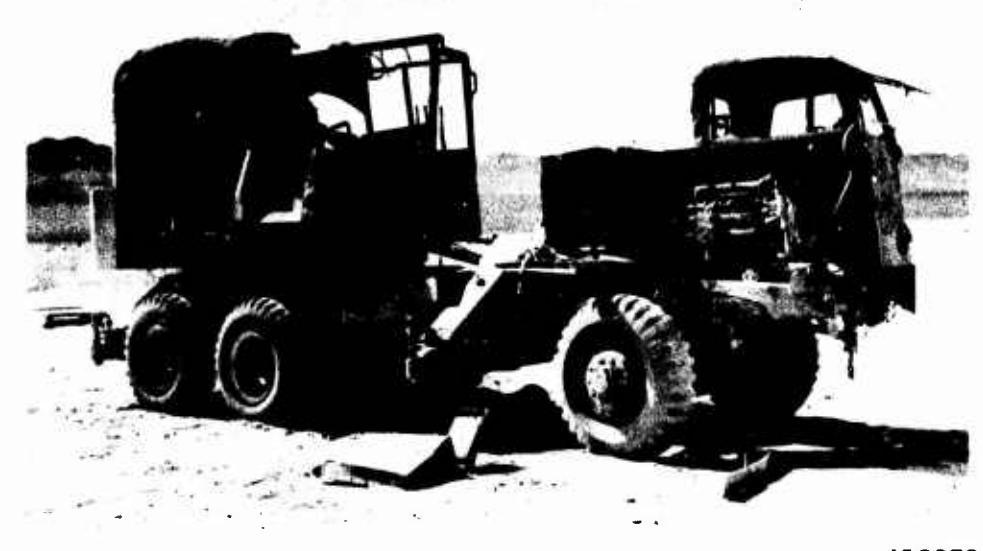
## Fig. 19. Crane, 2700 ft; after test.

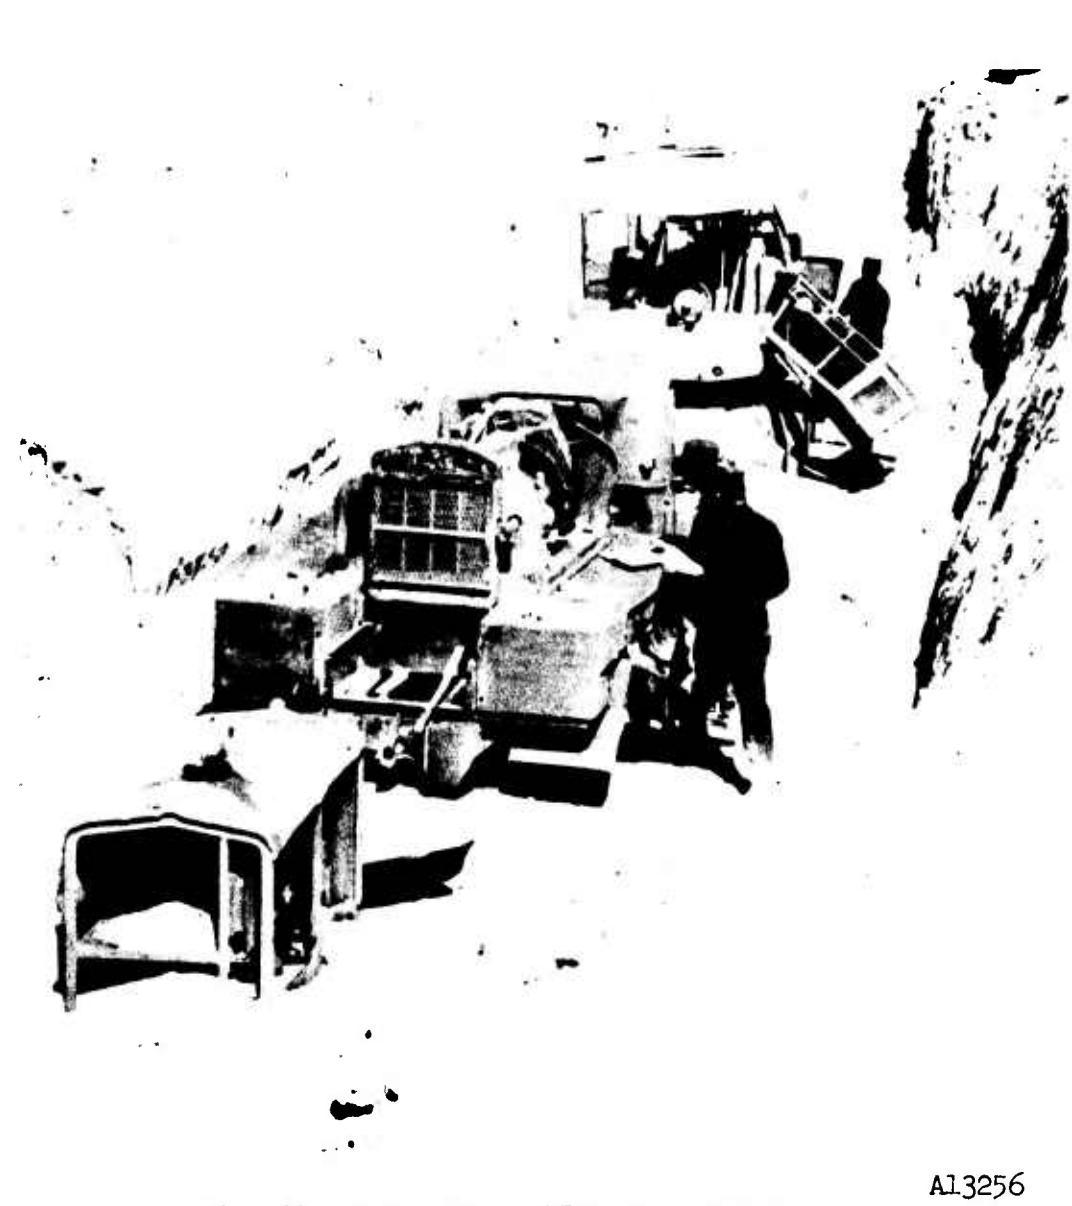
Compressors. At the 2100-ft range, the exposed air d. compressor was destroyed; and at the 2700-ft range, damage was moderate. The slots provided good protection at both ranges; the damage was reduced to the light category and to such a degree that limited operation of the exposed compressor could have been undertaken quickly. The use of unserviceable items prevented an on-thespot test of the observed light damage. Fig. 20 shows the effect of the reflected shock wave. (Note that the generator is separated from its pallet, and the warped crane and grader cabs as well as the bent cable reel and hoods of the compressor are all slanting toward GZ; a similar but not so intense an effect is indicated in Fig. 21.) Fig. 22 illustrates the complete disintegration in the trail of chassis, engine, compressor, and bed leading back toward GZ. (In Fig. 23, note that the rear suspension was broken when the item rolled over.)

Fig. 21. Compressor, 2700 ft; after test. . . .

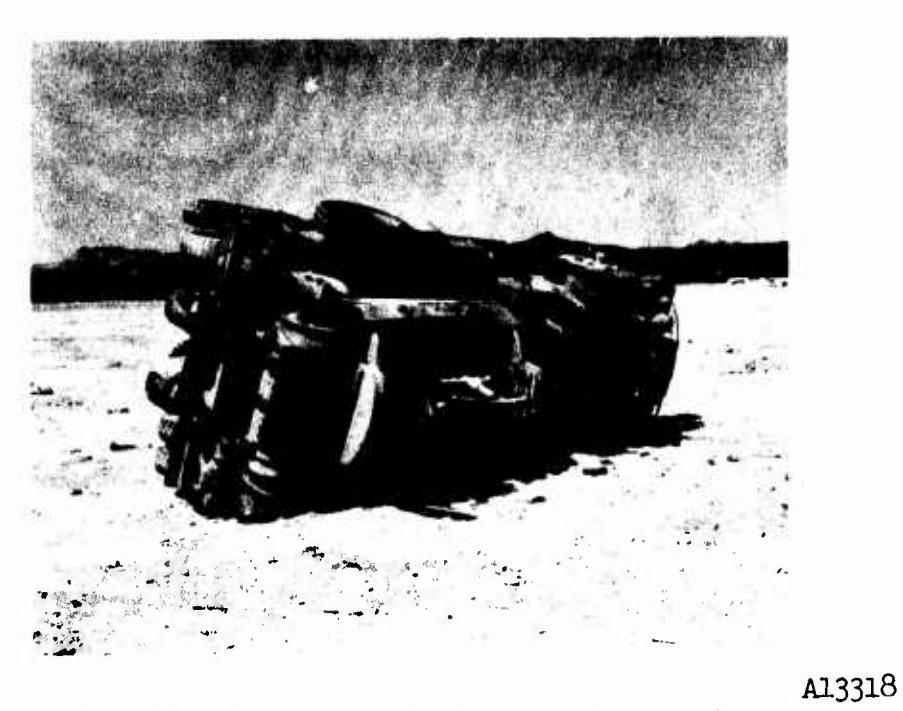
Fig. 23. Compressor, 2700 ft; after test.

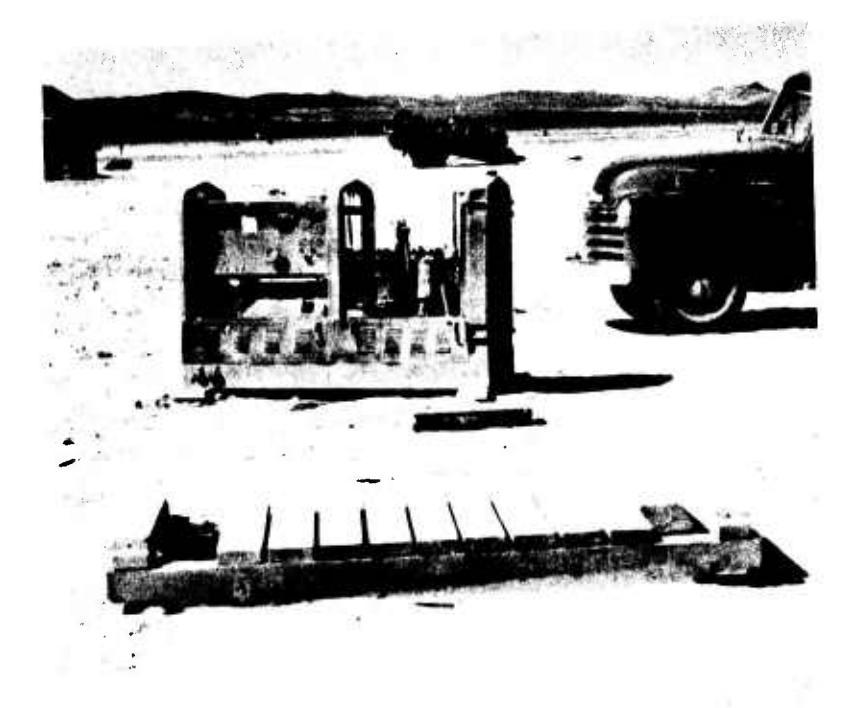
e. <u>Generators</u>. At the 2100-ft range, the exposed generator was destroyed; and at the 2700-ft range, damage was moderate. The slots provided fair protection; at the 2100-ft range, damage was reduced to the moderate category; and at the 2700-ft range, to the light category. Figs. 20, 24, and 25 show the generator separated from its skid or pallet mounting after test (also see Fig. 26). A smaller slot would have limited the reflected shock wave and displacement, and would have decreased the resulting damage.

Fig. 25. Generator, 2700 ft; after test.

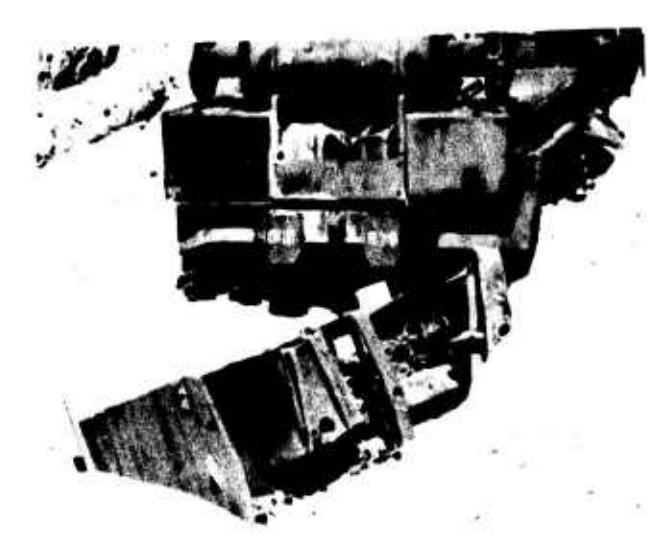
Fig. 26. Generator, 2100 ft; after test. (inset from Fig. 17)
